**Flood Control Project Maintenance  
Levee Inspections**

**Fall 2019 Levee Maintenance Deficiency Summary Report**

**San Joaquin River Basin**

**Reclamation District No. 2094 Walthall**

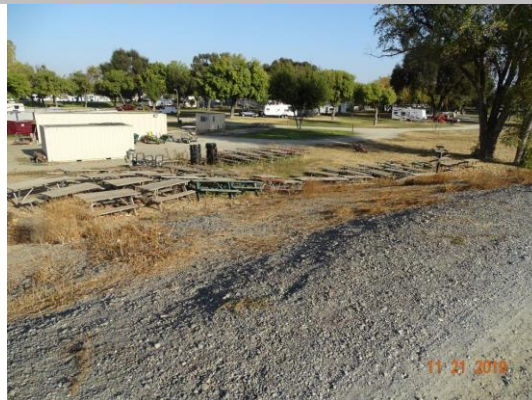
Photo 1 of 2 : FA\_2019\_RD2094\_320\_4\_20191121\_00016.jpg

LM Start	0.10	Rating **	M	Issue No.	4
LM End	0.10	Issue Type +	En	Location *	WS
Category	Earthen Levee			GPS Latitude/Longitude	
				Start	End
Item	Encroachments			37.771685 °	37.771685 °
				-121.300239 °	-121.300239 °
DWR ID	DWR_RD2094_01_s_2012_4				
Comment Code					
RA : Ramp					
Inspector Comment					
An access ramp has been built on the waterside and extends into the channel. This could potentially alter the channel capacity. This item was also noted in the USACE comments.

View of ramp on waterside slope. Fall 2019

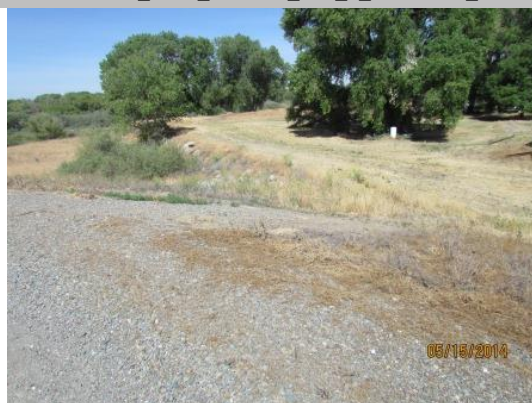
Photo 2 of 2 : FA\_2019\_RD2094\_320\_4\_20190830\_00001.jpg

Tire marks shown onto the ramp from levee. Raised area extends to the trees in the background in the center of the photo.

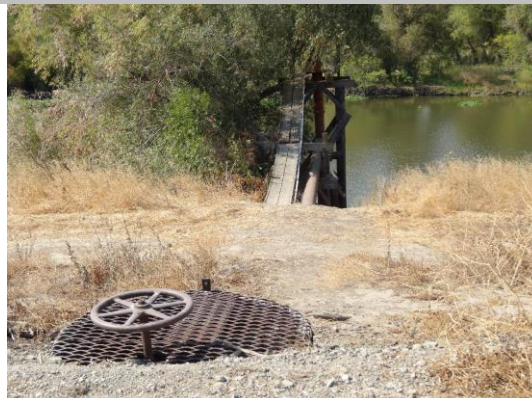
Photo 1 of 3 : UCIP\_FA\_2019\_21464\_36405.jpg

Comment Code					
Inspector Comment					
DS_ID:23086 FS_ID:21464 EP_NO: N/A Repair Type: Non-Urgent Crossing Status: Found UCIP Comments: - walkway in poor condition and needs repair.- electric conduit on waterside. FIELD_STRUCT_DESC: 14-inch concrete encased steel irrigation discharge pipe and galvanized iron (GI) electrical conduit through the levee, 10 feet below the crown. Two concrete cutoff walls. Pump mounted on a pile structure in the stream. Slide gate in a 54-inch corrugated metal pipe (CMP) riser on the waterside (WS) shoulder. Concrete distribution box and service pole at the landside (LS) toe. Installed by USACE in 1962. [Additional Reference(s): DWR Levee Log, 2005. USACE San Joaquin O&M Manual 3, December 1968, (HLM 0.66)]. FS Date: 9/10/2013

WS view: gate valve in CMP riser (bottom) and pipe & pump (top) on piling structure in the channel.

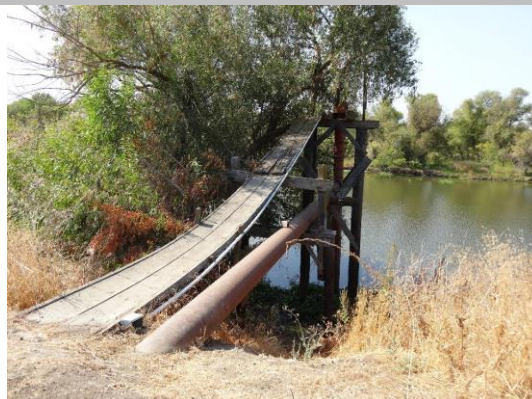
Photo 2 of 3 : UCIP\_FA\_2019\_21464\_36404.jpg

WS view: pump on piling structure in the channel. Pipe (right- bottom) and conduit (bottom- left).

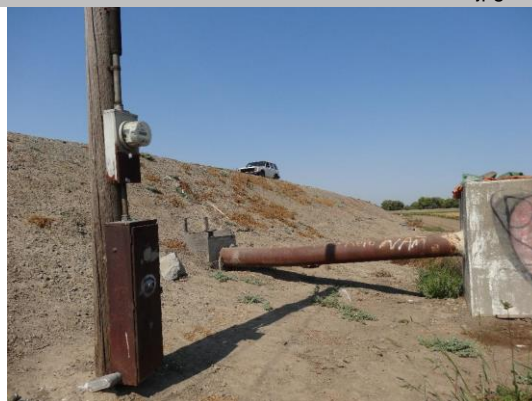
Photo 3 of 3 : UCIP\_FA\_2019\_21464\_36403.jpg

LS view: exposed pipe, service pole, and concrete distribution box on levee toe.

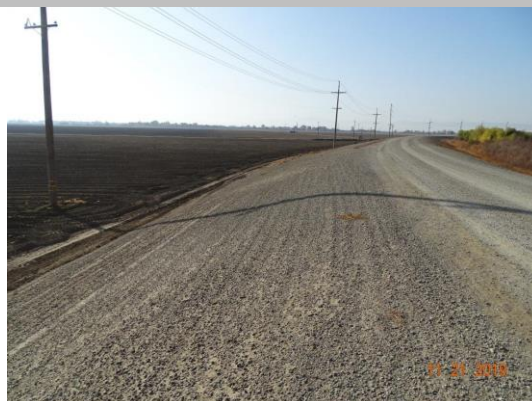
Photo 1 of 1 : FA\_2019\_RD2094\_320\_6\_20191121\_00017.jpg

LM Start	0.91	Rating **	A	Issue No.	6
LM End	0.91	Issue Type +	Ma	Location *	LS
Category	Earthen Levee			GPS Latitude/Longitude	
				Start	End
Item	Vegetation			37.764209 °	37.764209 °
				-121.293559 °	-121.293559 °
DWR ID	DWR_RD2094_01_f_2019_6				
Comment Code					
V1 : Control annual grass and weeds on the levee slopes and easements.					
Inspector Comment					
Annual vegetation is well maintained.

View of vegetation on landside slope. Fall 2019

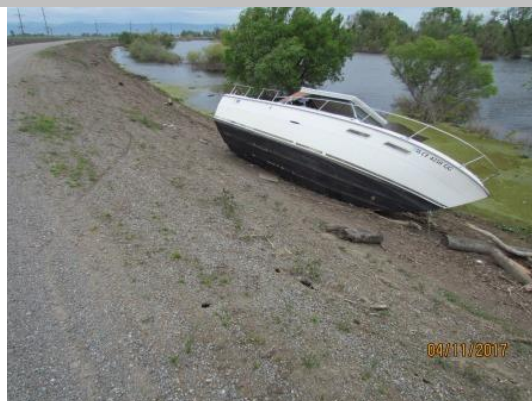
Photo 1 of 1 : FA\_2019\_RD2094\_320\_8\_20190830\_00002.jpg

LM Start	0.91	Rating **	M	Issue No.	8
LM End	0.91	Issue Type +	En	Location *	WS
Category	Earthen Levee			GPS Latitude/Longitude	
				Start	End
Item	Encroachments			37.764169 °	37.764169 °
				-121.293562 °	-121.293562 °
DWR ID	DWR_RD2094_01_s_2017_8				
Comment Code					
AV : Abandoned vehicles					
Inspector Comment					
There is an abandoned boat on the waterside slope.

View of the boat on the levee slope.

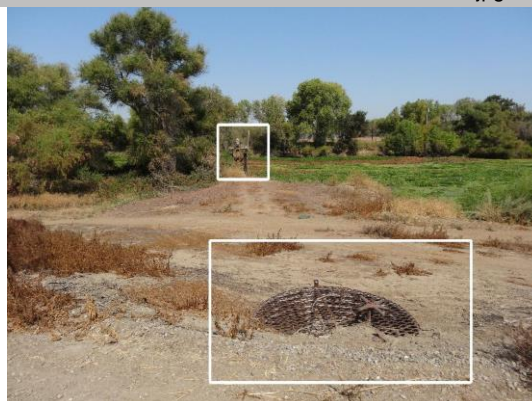
Photo 1 of 3 : UCIP\_FA\_2019\_21544\_36524.jpg

Comment Code					
Inspector Comment					
DS_ID:23087 FS_ID:21544 EP_NO: N/A Repair Type: Non-Urgent Crossing Status: Found UCIP Comments: - working as drainage system during field visit. Pump was not running.- electric conduit on WS- open pipe end in CMP riser. CMP needs cleaning. FIELD_STRUCT_DESC: 20-inch concrete encased steel irrigation discharge pipe through the levee, 10 feet below the crown. Two concrete cutoff walls. Pump mounted on a pile structure in the stream. Slide gate in a 54-inch corrugated metal pipe (CMP) riser on the waterside (WS) shoulder. Concrete distribution box and service pole at the landside (LS) toe. [Additional Reference(s): DWR Levee Log, 2005. USACE San Joaquin O&M Manual 3, December 1968, (HLM 1.27)]. FS Date: 9/10/2013

WS view: overview of pump (top) and CMP riser (bottom)

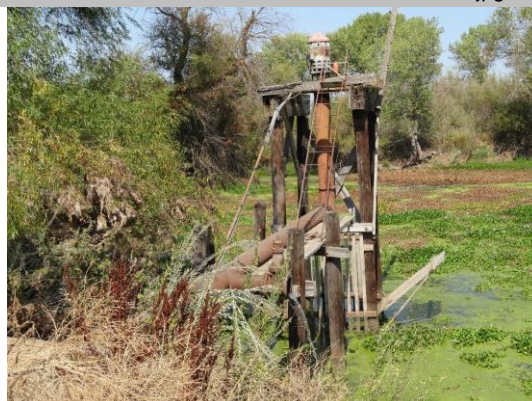
Photo 2 of 3 : UCIP\_FA\_2019\_21544\_36523.jpg

WS view: pipe and pump on piling structure in the channel. Walkway in poor condition.

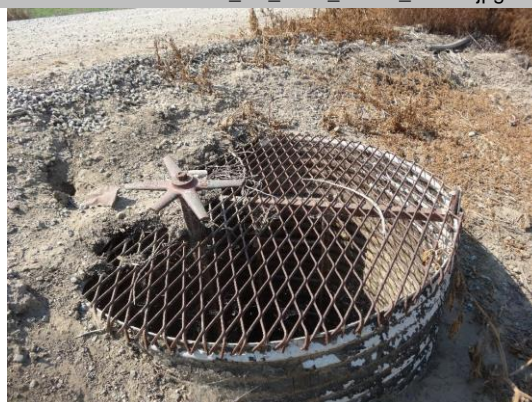
Photo 3 of 3 : UCIP\_FA\_2019\_21544\_36522.jpg

WS view: damaged gate valve handle in CMP riser on levee shoulder.

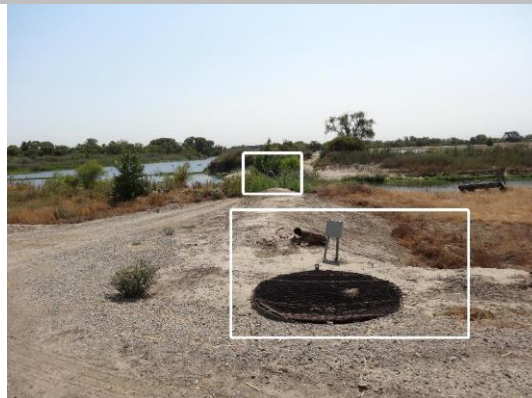
Photo 1 of 3 : UCIP\_FA\_2019\_41726\_36502.jpg

Comment Code						
Inspector Comment						
DS_ID:23088						
FS_ID:41726						
EP_NO: N/A						
Repair Type: Non-Urgent						
Crossing Status: Found						
UCIP Comments: - dense vegetation on WS.- working during field survey.- slide gate not found on WS.						
FIELD_STRUCT_DESC: 20-inch concrete encased steel irrigation discharge pipe through the levee, 6 feet below the crown. Two concrete cutoff walls. Slant pump mounted on a frame structure on the stream bank. Slide gate in a 54-inch corrugated metal pipe (CMP) riser on the waterside (WS) shoulder. Concrete distribution box and service pole at the landside (LS) toe. [Additional Reference(s): DWR Levee Log, 2005. USACE San Joaquin O&M Manual 3, December 1968, (HLM 2.30)].						
FS Date: 9/10/2013

WS view: slant pump (top) on stream bank and CMP riser on levee shoulder.

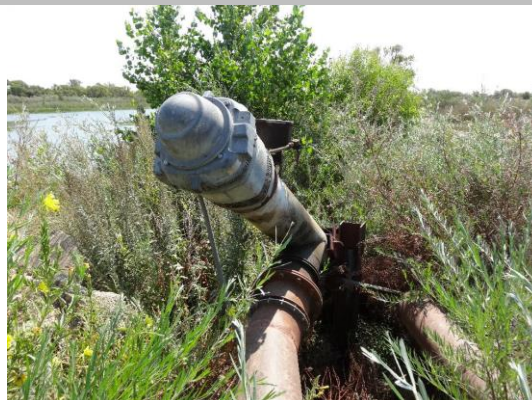
Photo 2 of 3 : UCIP\_FA\_2019\_41726\_36501.jpg

WS view: slant pump on stream bank and dense vegetation on stream bank.

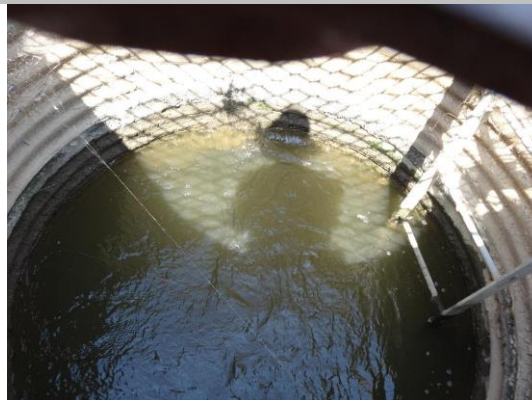
Photo 3 of 3 : UCIP\_FA\_2019\_41726\_36500.jpg

WS view: inside view of CMP riser on levee shoulder. No slide gate found.

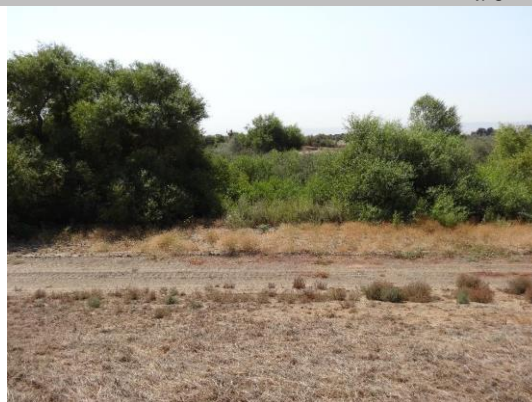
Photo 1 of 3 : UCIP\_FA\_2019\_21545\_36529.jpg

LM Start	2.45	Rating **	M	Issue No.	16
LM End	2.45	Issue Type +	En	Location *	
Category	Supplemental			GPS Latitude/Longitude	
				Start	End
Item	DRAFT DWR UCIP Field Study			37.752308 °	37.752308 °
				-121.293191 °	-121.293191 °
DWR ID	23089				
Comment Code					
Inspector Comment					
DS_ID:23089 FS_ID:21545 EP_NO: N/A Repair Type: Non-Urgent Crossing Status: Found UCIP Comments: - no pipes found on either side of the levee.- concrete distribution box on LS. Soil erosion around distrinction box. FIELD_STRUCT_DESC: Rectangular concrete distribution box on the landward toe FS Date: 9/10/2013

WS view: no pipe found on waterside.

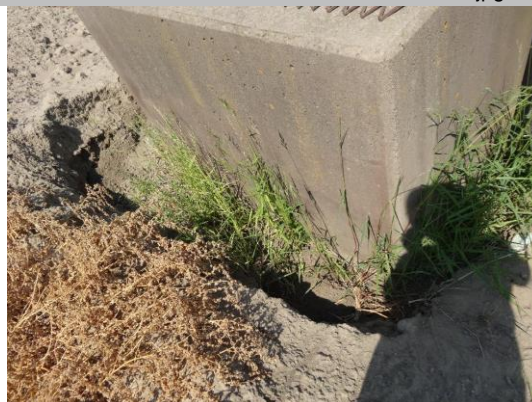
Photo 3 of 3 : UCIP\_FA\_2019\_21545\_36527.jpg

LS view: erosion around a concrete standpipe on the landside toe.

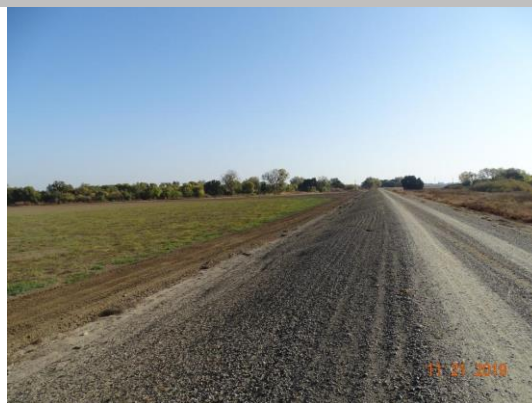
Photo 1 of 1 : FA\_2019\_RD2094\_321\_1\_20191121\_00001.jpg

LM Start	0.40	Rating **	A	Issue No.	1
LM End	0.40	Issue Type +	Ma	Location *	LS
Category	Earthen Levee			GPS Latitude/Longitude	
				Start	End
Item	Vegetation			37.760637 °	37.760637 °
				-121.306370 °	-121.306370 °
DWR ID	DWR_RD2094_02_f_2019_1				
Comment Code					
V1 : Control annual grass and weeds on the levee slopes and easements.					
Inspector Comment					
Annual vegetation is well maintained.

View of vegetation on landside slope. Fall 2019
